DEPARTMENT OF TRANSPORTATION

Contract #: 04-0120F4Cty: SF/ALA Rte: 80 PM: 13.2/13.9File #: 99.28**WELDING INSPECTION REPORT****Resident Engineer:**Siegenthaler, Peter**Address:** 333 Burma Road**City:** Oakland, CA 94607**Report No:** WIR-019317**Date Inspected:** 03-Jan-2011**Project Name:** SAS Superstructure**OSM Arrival Time:** 700**Prime Contractor:** American Bridge/Fluor Enterprises, a JV**OSM Departure Time:** 1900**Contractor:** Zhenhua Port Machinery Company, Ltd (ZPMC) Chanxing Island**Location:** Shanghai, China

Bridge No: 34-0006**Component:** OBG Segment**Summary of Items Observed:**

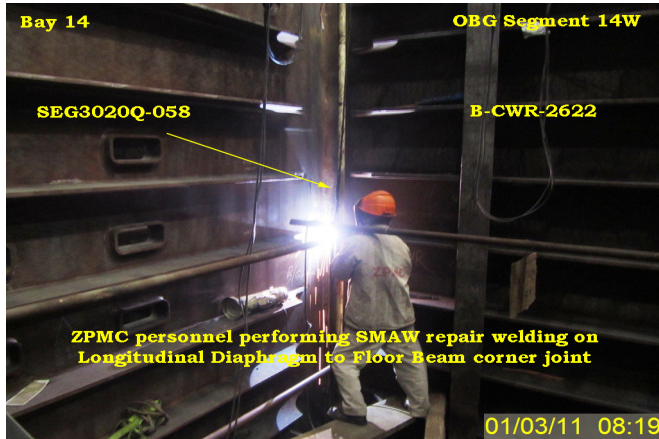
Unless otherwise noted, all work observed on this date appeared to be in general compliance with the applicable contract documents.
